Inlet Bay Apartments Project

POLY FOAM GROUND IMPROVEMENT PROJECT

The project is a luxury apartment complex pool deck in need of soil stabilization and ground improvement.

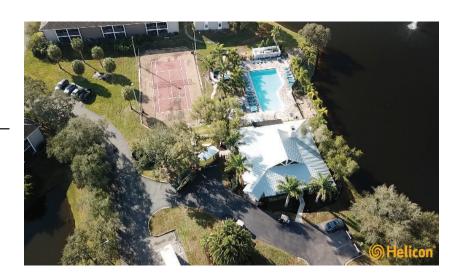
Soil conditions with large voids underneath pool deck

The voids underneath the pool deck were discovered when the apartment complex owners replaced a wood deck that was attached to the brick paver pool deck. When the old wood deck was removed, the voids were obviously a hazard, that is when Helicon was contacted to remedy the situation. The poly foam was injected underneath the pool deck to fill large voids that could have compromised the integrity of the entire pool deck.

Over 1,200 lbs of poly foam was injected underneath the pool deck during the course of this project. The poly foam was documented to have sufficient uplift resistance capacity and provides the necessary support for the pool deck area. All work was completed in a timely manner and the apartment complex owners were able to continue building their attached wood deck immediately thereafter.
