City of Wauchula Stormwater

PERMEATION GROUT PROJECT

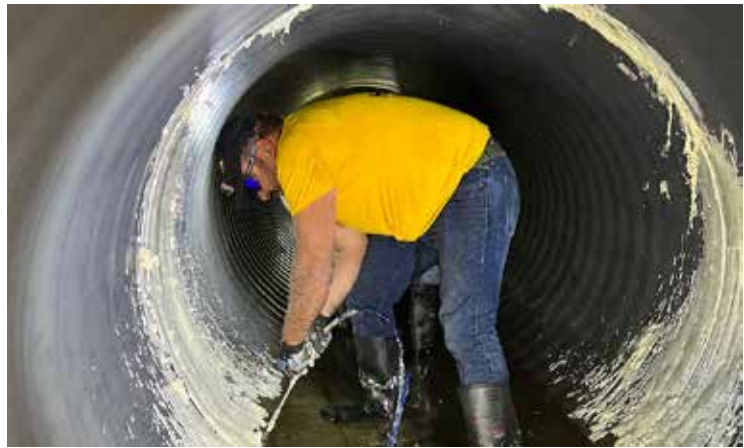
A critical culvert in Wauchula, Florida, was facing a significant issue. The joints between the newly installed vinyl storm drain were not sealing properly, causing water to seep through the connection gaps and erode the surrounding soil. This can be a common problem and can be expensive to rip out and replace. This was leading to surface subsidence, safety hazards, and potential damage to the infrastructure.

The project consisted of repairing a 5-foot-diameter stormwater drain that had gaps that were causing the soil above to erode through the gaps. A new road was laid on top of the existing stormwater drain, and when the pressure of the road compacted the soil underneath, it caused the drain to have gaps. There were two options: rip out the brand new road and replace it with a new road and new drain, or have Helicon repair the drain at a fraction of the cost.

To address the specific issue of the non-flush pipe joints, a two-step approach was employed:

- **Oakum Preparation:** Oakum, a type of absorbent material, was soaked in F400 resin, a flexible, hydrophobic polyurethane.
- **Joint Packing:** The resin-soaked oakum was packed tightly into the gaps between the pipe joints. The moisture in the soil triggered a reaction, causing the oakum to expand and seal the joint.
- **Curing:** The F400 resin cured, forming a durable, flexible gasket that formed a barrier to keep the injected AP720 from flowing into the storm drain.

- **Drilling:** Small-diameter holes were drilled around the joint at strategic locations.
- **Injection:** A high-expansion polyurethane resin, AP Fill 720, was injected into the holes. This encapsulated the joint, filling voids and tightening the surrounding soil.

- Preparation for the polyurethane injections involved soaking Oakum in F400 resin and stuffing it into the open joints. This served as a form or barrier to prevent the injected AP720 from freely flowing into the storm drain. The barrier ensured the material could permeate and seal the seams effectively.
- Small holes were drilled adjacent to the seams in a clock-like pattern around the circular drain.
- Port valves were installed in a clock pattern adjacent to each of the seams at positions 12 o'clock, 2 o'clock, 4 o'clock, 6 o'clock, 8 o'clock, and 10 o'clock. Material was pumped into each point around the clock until it emerged from the seams.
- The operator completed approximately two laps around the clock, injecting material through each port valve until the process was complete

All the joints with gaps were completely sealed. The Helicon team completed this process in a single day, saving the county hundreds of thousands of dollars. The alternative would have been to rip out the roadway, excavate the vinyl storm drain, and replace it, hoping the newly installed drain seams aligned correctly. That alternative would have taken weeks, if not months, to complete. In contrast, Helicon's process minimized disruption, saved resources, and was better for the environment, as existing materials were preserved and no new materials were required for replacement.
