Seawall Erosion Repair St. Petersburg, FL Home

CHEMICAL GROUT WITH JET FILTER INSTALLATION

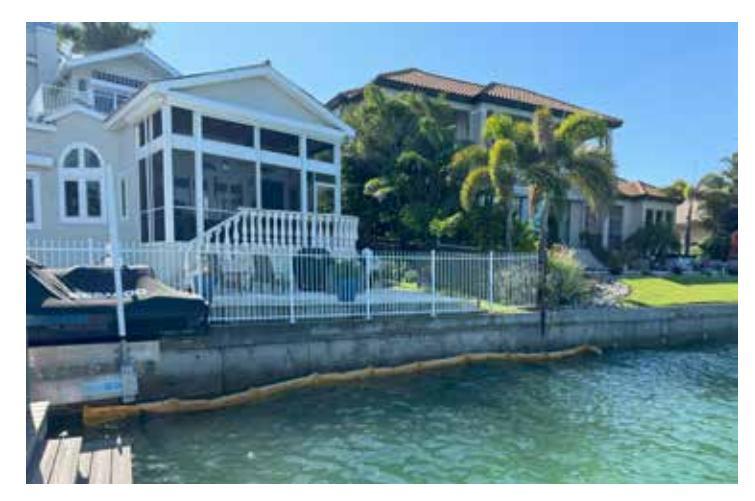
The homeowner observed signs of settlement and instability in their backyard and around the pool area. This included cracks in the pool deck, sinking pavers, and cracks in the concrete. Upon further investigation, it was discovered that significant soil erosion and voids had developed behind the seawall. It was estimated that these voids extended approximately 10 to 15 feet behind the seawall and were several feet deep in some areas. These voids were causing the seawall to lose support, leading to the observed settlement issues. The erosion was likely caused by a combination of factors, including the age of the seawall, the type of soil, wave action, and water intrusion.

To address the soil erosion and void formation, chemical grouting was employed. Chemical grouting involves injecting a specialized expanding polyurethane resin into the voids behind the seawall. This resin expands and fills the voids, compacting the surrounding soil and providing structural support to the seawall. Chemical grouting was selected for this project because it offered a minimally invasive solution that could address the void formation without the need for extensive excavation or disturbing the pool deck.

The chemical grout system utilized consisted of a resin and a hardener that, in this case, were pre-mixed in a truck before being pumped into the soil through small injection ports. As the mixture reacts, it expands and fills the voids, creating a dense and stable mass. The properties of the polyurethane grout contribute to its effectiveness in this application. It has a high density, providing substantial weight to counteract soil pressure, high compressive strength to withstand the load of the soil and the seawall, and low permeability to prevent water from infiltrating and causing further erosion. The expansion pressure of the grout compacts the surrounding soil, further enhancing stability.

Jet filters were also installed in the sewall. Jet filters are a more advanced type of drainage system than traditional weepholes. Jet filters incorporate a filter that prevents debris from clogging the opening. They function by providing a drainage path for water trapped behind the structure, relieving hydrostatic pressure, and preventing the loss of soil and backfill material.
