Henry Fontanills Project

UNDERPINNING AND POLY FOAM PROJECT

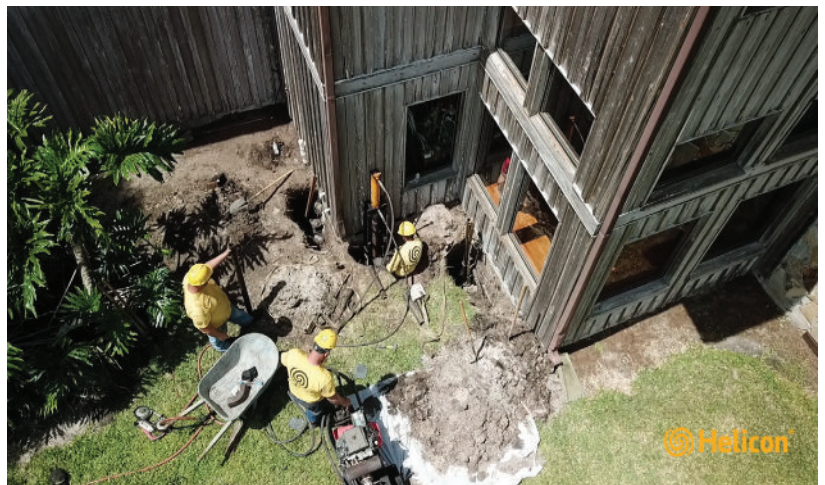
The project is a two-story, wood frame, residential home. The building has undergone subsidence in a corner of the foundation due to organic soil layer deterioration.

Helicon developed an underpinning simultaneous lift procedure with poly foam lift as the remedy to the situation. The underpins were installed and hydraulically lifted the sunken foundation 8 inches. The poly foam injections were done after the underpinning to fill in any gaps beneath footer or above footer. This solution was designed to meet or exceed the design load criteria for the building. Efficient planning & coordination was key to overcoming the challenges & limitations. 140+/-pounds of polyurethane material were injected into a total of 13 chemical grout points on the exterior of the structure. The underpinning and poly foam injection work was completed on time and within budget.
