Hidden Brook Condominiums

COMPACTION GROUT AND UNDERPINNING PROJECT

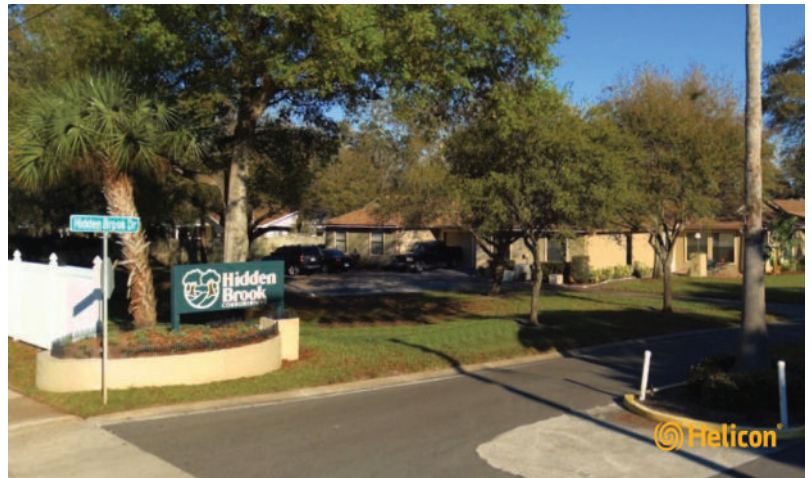
The project is a residential condominium complex that experienced sinkhole activity. The Geotechnical Engineer of Record recommended a solution of low mobility and high mobility compaction grout and underpinning to improve the load bearing capacity of the existing soils at the site.

The intent of grouting operations was to seal the surface of the limestone, fill voids and stabilize weakened soils that underlie the building footprint. Due to a ground cover collapse that occurred in front of one of the buildings, underpinning needed to be utilized for preventative purposes prior to compaction grouting at this building.

- Sandy/Silty soil conditions
- Ground Collapse
- Deep sinkhole conditions in various areas

Helicon worked alongside the geotechnical design team to develop a compaction grout and underpinning program designed to meet the building code load criteria. The underpinning system was installed to a competent bearing stratum as defined by the engineer. An added benefit of the underpinning system was that the loose soils near the surface were bypassed, negating the need for additional near-surface soil improvement such as chemical grouting.

A program of low mobility displacement grout was utilized to stabilize the sinkhole conditions at the structure. In instances where competent limestone and/or sinkhole conditions were encountered at depths shallower than 20 feet below ground surface, specifications were met to implement a high mobility subsurface grouting program. Efficient planning & coordination was key to overcoming the challenges & limitations.
