95-Year-Old Home Crawl Space Repair

CRAWL SPACE REPAIR WITH GALVANIZED STEEL JACKS

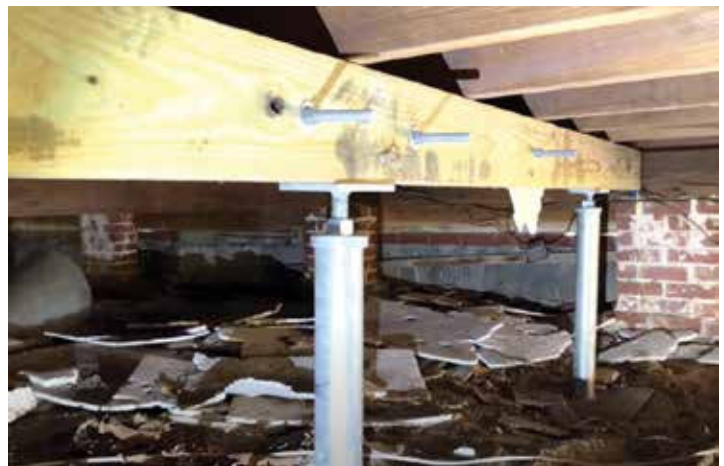
The primary challenge in this project was working with a nearly 100-year-old home. Any modifications had to be carefully planned and executed to preserve the home's foundation.

Hidden Damage: The age of the home meant that there could be hidden structural issues that were not immediately apparent.

- Expert Diagnosis: Identifying the root cause of the floor sagging as foundation settlement.
- Strategic Foundation Repair: Installing galvanized steel pier jacks and new support beams to stabilize the foundation and lift the house.
- Innovative Solution: Adding stone to the ground and installing galvanized steel jacks to support the beams, providing a durable and effective solution.
- Meticulous Execution: The work was carried out with precision and attention to detail, minimizing disruption to the home's structure and integrity.
- By implementing these strategies, Helicon was able to revitalize the 95-year-old Clearwater home, restoring its structural integrity and ensuring its longevity.
